TIME IN A MODEL

Laser scanning allows experts to develop a restoration plan for the artwork at Hoover Dam.

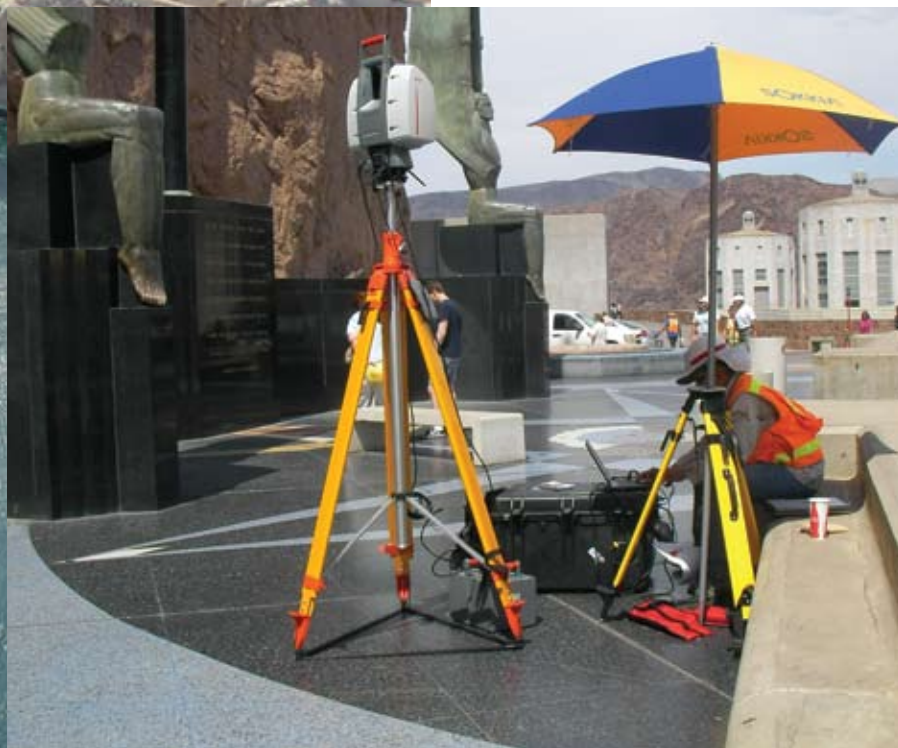
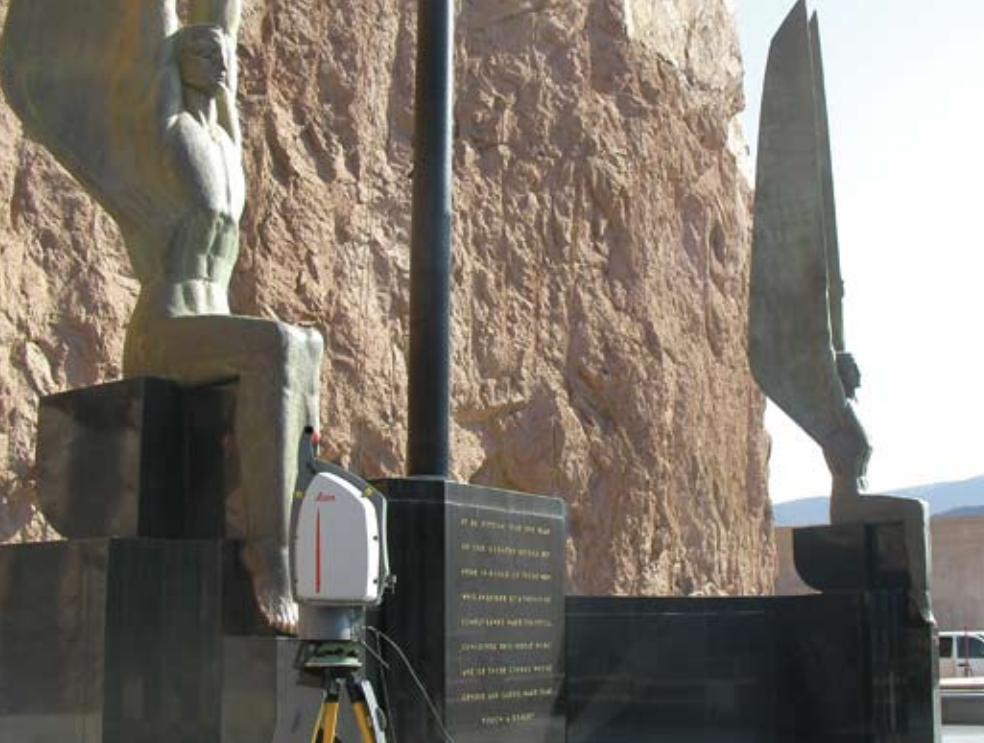
Built soon after Hoover Dam’s completion, historic Monument Plaza is showing signs of age. The Bureau of Reclamation looked to noninvasive, nondestructive laser scanning technology to gather as-built conditions.

With a detailed 3D model laser-scanned to engineering accuracy, Reclamation and its consultants are able evaluate structural deterioration of Monument Plaza and determine an effective plan for rehabilitation.

The terrazzo floor is cracking and showing weather damage. The Winged Figures are patinated and appear to be aging well. However, other bronze features on the plaza are cracking and showing wear, and some are missing pieces.

To date, the entire surface area of Monument Plaza has been surveyed twice—once in the summer and once in the winter. “The results are impressive,” Orosco says. “In a very short time, we have created a baseline 3D model of Monument Plaza that is helping us evaluate structural changes in a clear visual manner. The scanner’s capabilities have allowed us to cut down on field labor costs, and the capture of additional data has been extremely useful for Reclamation clients.”
